INDOOR AIR QUALITY ASSESSMENT

Plymouth River Elementary School 200 High Street Hingham, Massachusetts

Prepared by:
Massachusetts Department of Public Health
Center for Environmental Health
Emergency Response/Indoor Air Quality Program
April 2007

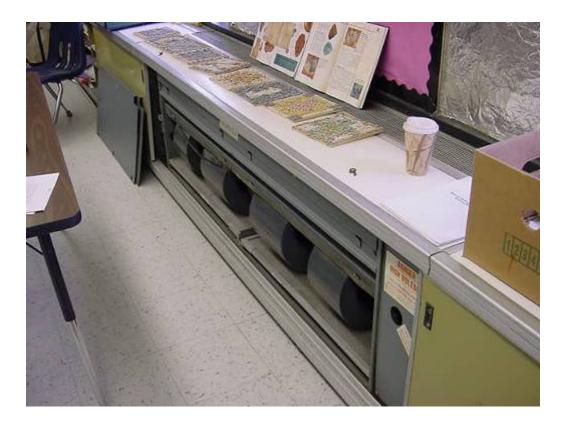
Fresh air in classrooms is supplied by unit ventilator (univent) systems (Picture 1).

Classroom Univent 1960's Vintage

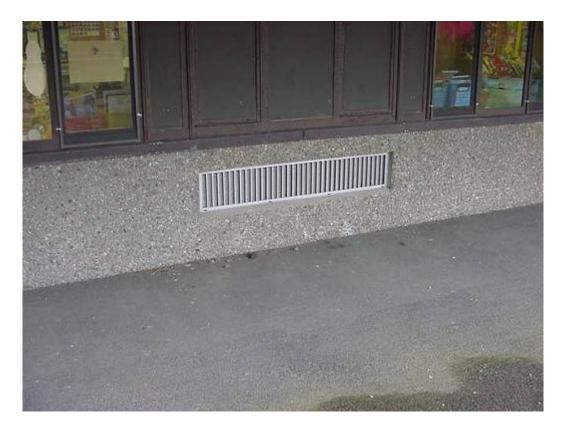
Univents are designed to draw air from outdoors through a fresh air intake located on the exterior walls of the building (Picture 2) and return air through an air intake located at the base of each unit (Figure 1). Fresh and return air are mixed, filtered, heated and provided to classrooms through a fresh air diffuser located in the top of the unit. Obstructions to airflow such as items

Univent Fresh Air Intake

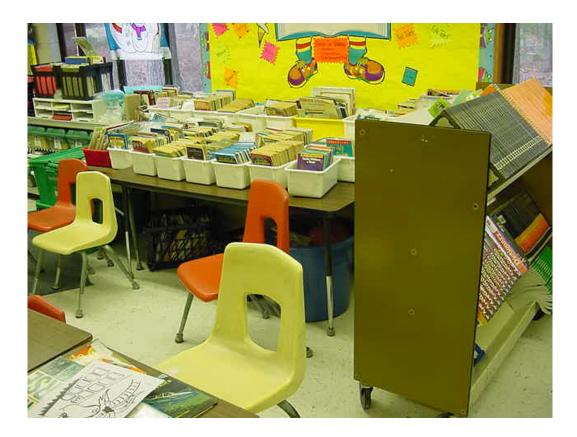
on univents and/or furniture in front of univent returns were observed in several classrooms (Picture 3). In order for univents to provide fresh air as designed, intakes must remain free of obstructions. Importantly, these units must remain activated and allowed to operate during periods of occupancy. Please note that ventilation equipment was likely installed when the building was constructed, therefore it is approximately 40 years old. Equipment of this age is difficult to maintain, since compatible replacement parts are often unavailable.

Univent Obstructed by Various Items

- Remove all blockages from univents and exhaust vents to ensure adequate airflow.
 Consider reconfiguring the layout of some classrooms to facilitate airflow.

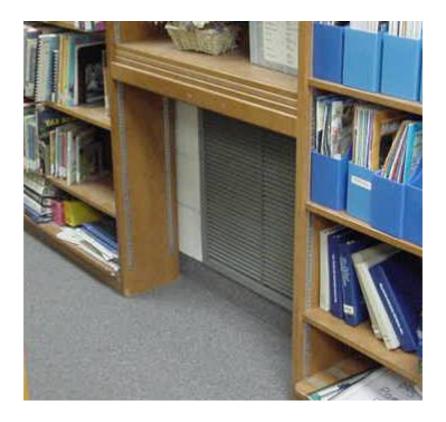
The mechanical exhaust system in classrooms consists of grated vents located on the front of coat closets ducted to rooftop motors (Picture 4). Unlike the univents which are original equipment, Mr. Field reported that the exhaust motors were replaced approximately 6 to 7 years ago.

Wall-Mounted Exhaust Vent

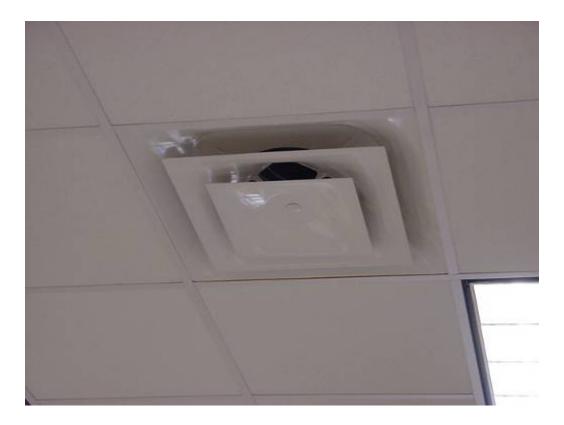
Mechanical ventilation and air-conditioning for office areas, the library/media center and computer lab is provided by rooftop air handling units (AHUs). Ceiling-mounted air diffusers ducted to the AHUs distribute fresh tempered air to the spaces (Picture 5). Return air is drawn into ceiling-mounted vents and ducted back to the AHUs (Picture 6).

Ceiling-Mounted Air Diffuser

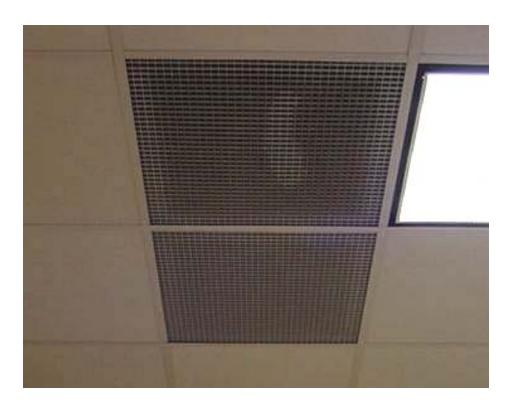
Several personal fans in classrooms and exhaust/return vents had accumulated dust and debris. If exhaust vents are not functioning (deactivated, broken belts, etc.), backdrafting can occur, which can re-aerosolize dust particles. Dust can also become aerosolized from personal fans when activated.

Ceiling-Mounted Return Vents, Note Dust Accumulation, (Indicated by clear spot disturbed by CEH staff)

- 13. Clean air diffusers, exhaust/return vents and personal fan blades periodically of accumulated dust.
- 14. Consider adopting the US EPA document, "Tools for Schools" to maintain a good indoor air quality environment on the building (US EPA, 2000). This document can be downloaded from the Internet at: http://www.epa.gov/iag/schools/index.html.

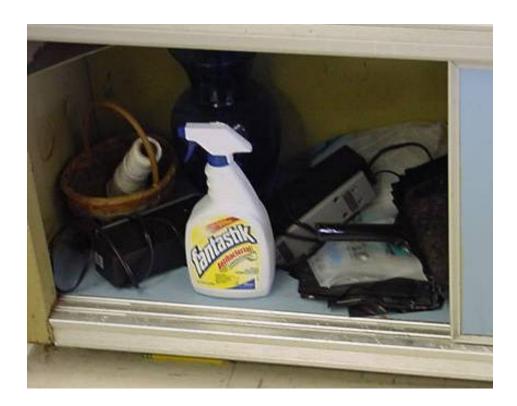
Spray Cleaning Product in Unlocked Cabinet under Sink

- 10. Store cleaning products properly and out of reach of students. Ensure spray bottles are properly labeled. *All* cleaning products used at the facility should be approved by the school department with MSDS' available at a central location.

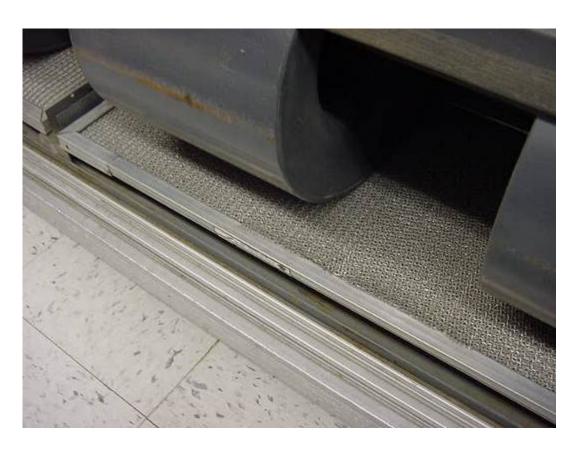
Several other conditions that can potentially affect indoor air quality were also identified. Univents are general equipped with filters that provide filtration to strain particulates from airflow. Univents at the PRES had metal/mesh filters (Picture 8), which provide minimal filtration and are difficult and time consuming to clean. In order to decrease aerosolized particulates, disposable filters with an increased dust spot efficiency should be installed. The dust spot efficiency is the ability of a filter to remove particulates of a certain diameter from air passing through the filter. Filters that have been determined by ASHRAE to meet its standard for a dust spot efficiency of a minimum of 40 percent (Minimum Efficiency Reporting Value equal to 9) would be sufficient to reduce many airborne particulates (Thornburg, 2000; MEHRC, 1997; ASHRAE, 1992). Note that increasing filtration can reduce airflow, a condition known as pressure drop, which can reduce efficiency due to increased resistance. Prior to any increase of filtration, a ventilation engineer should be consulted as to whether the univents can maintain function with more efficient filters.

Metal/Mesh Filters Installed in Univents

- 11. Consider replacing metal HVAC filters with higher efficiency disposable filters. Note that increased filtration can reduce airflow produced through increased resistance. Prior to any increase of filtration, the univents should be evaluated by a ventilation engineer to determine whether they can maintain function with more efficient filters.

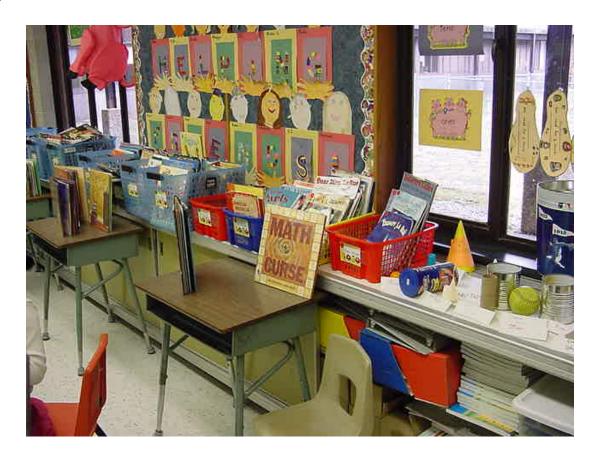
Finally, of note was the amount of materials stored in some classrooms. Items were observed on windowsills, tabletops, counters, bookcases and desks (Pictures 3 and 9). The large number of items stored in classrooms provides a source for dusts to accumulate. These items, (e.g., papers, folders, boxes) make it difficult for custodial staff to clean. Items should be relocated and/or be cleaned periodically to avoid excessive dust build up.

Accumulated Items in Classroom

- Relocate or consider reducing the amount of materials stored in classrooms to allow for more thorough cleaning. Clean items regularly with a wet cloth or sponge to prevent excessive dust build-up.
